BOILER CODE OF  
PRACTICE (BCOP)

## GUIDANCE NOTE

# INNER FIREBOX REPAIR AND RENEWAL

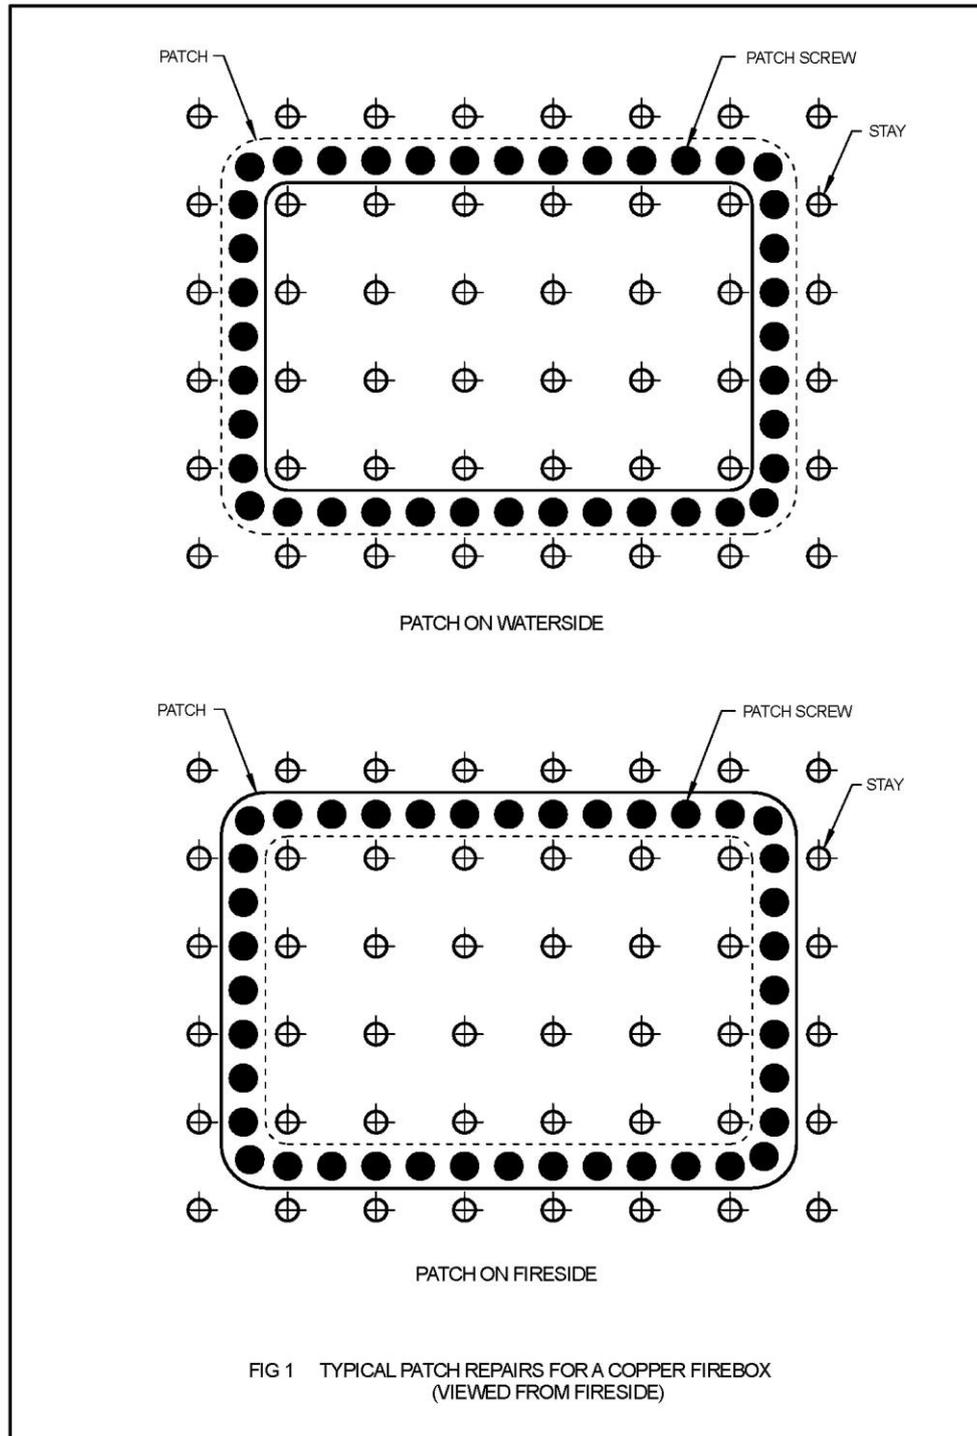
The defective area of plate should be cut away and the patch ideally applied to the waterside of the hole, unless this would severely restrict the water space in which case it may be applied to the fireside. See Fig 1.

FIG 1 TYPICAL PATCH REPAIRS FOR A COPPER FIREBOX (VIEWED FROM FIRESIDE)

In all cases, the overlap of the patch should be kept to a minimum to reduce the risk of the caulked edge becoming overheated. The patch should be carefully bedded to the firebox plate and the patch screws should normally be at between 1 7/8 and 2 1/8" pitch. (For further details of patch screws see separate Guidance Note B9025).

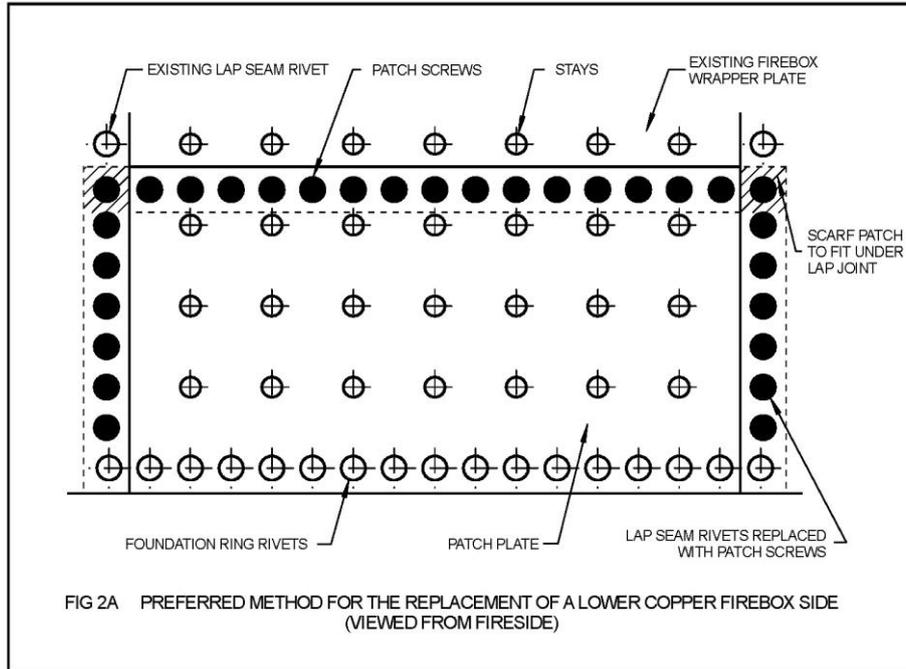
Alternatively, the patch can extend down to the foundation ring as shown in Fig 2A.

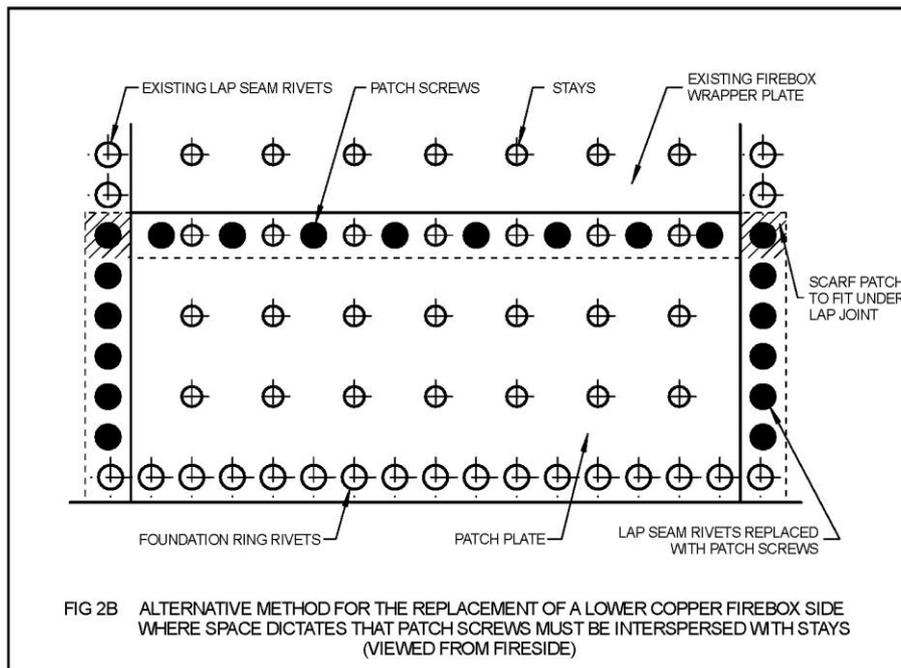
If space is restricted then lap seams may encompass both patch screws and stays as shown in Fig 2B.

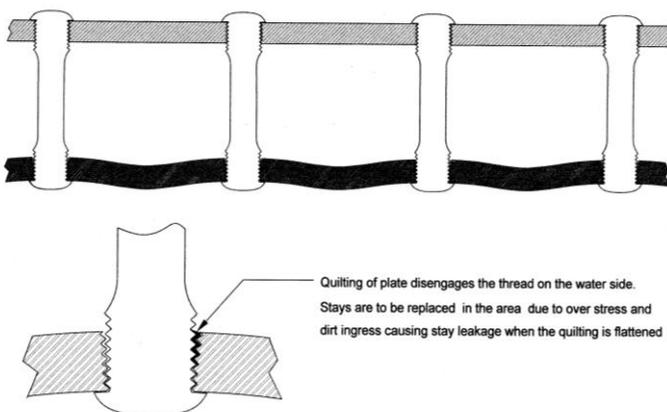
If the boiler pressure has pushed the firebox plate towards the fireside in an area between some stays, the plate is normally referred to as being "quilted".

Quilting of the plate is caused by a loss of strength due to overheating as a result of a shortage of water, or the build up of scale or oil on the waterside. It could also be due to a lamination within the plate.

In all cases the cause should first be identified and corrected. In addition, the thickness of the plate should be checked by ultrasonic testing or by drilling a small hole which is subsequently plugged. This will permit the identification of thinned or laminated plates.

If the quilting is not severe, and the plate still has sufficient thickness, then repair may not be essential but the condition should be monitored in service. Alternatively, the plate can either be pushed back with a jack,

or a rivet gun and a flat snap. However, in more extreme cases the section of plate should be replaced. Note that any pushing back of the plate should be performed cold as localised heating can result in cracking.

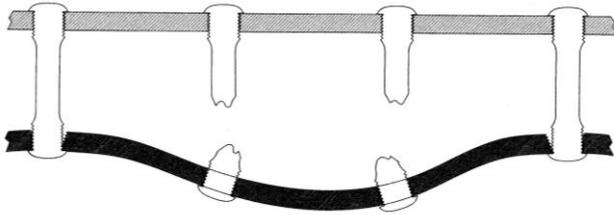
Bulging of the plate is caused by one or more broken stays.

If the bulging is not severe, and the plate still has sufficient thickness, it can either be pushed back with a jack, or a rivet gun and a flat snap. However, in more extreme cases the section of plate should be replaced. Note that any pushing back of the plate should be performed cold as localised heating can result in cracking.

**Fig 4: Bulged Plates**

Any stays in the vicinity of those that have broken will have been subjected to additional loading and may have been weakened. These stays should therefore be renewed along with the broken ones.

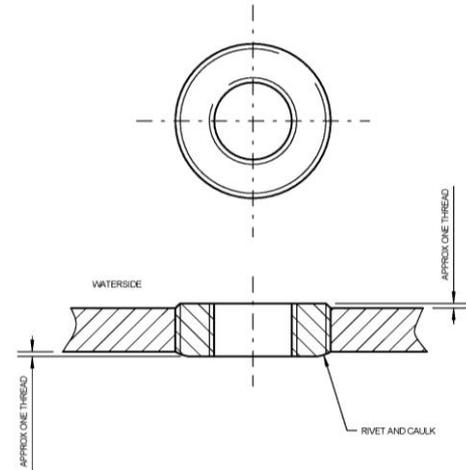
If there are no alternative hole positions available then, subject to there being sufficient plate thickness, a damaged hole may be opened out and threaded to take a bush. The bush should be riveted and caulked on the fireside to prevent it coming loose. See Fig 5.

**Fig 5: Typical method for fitting a Fusible Plug bush to Copper Fireboxes**

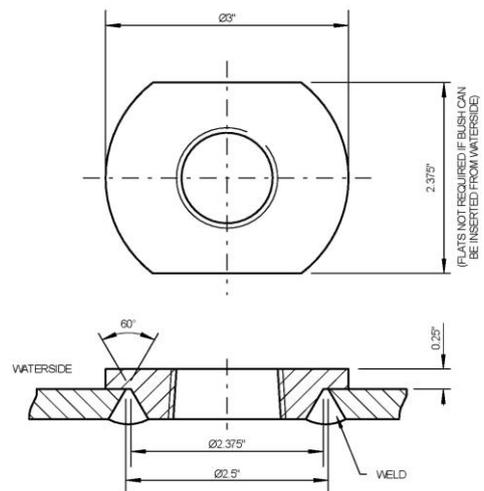
The bush should ideally be of “top hat” section and be fitted from the waterside. Alternatively, it can be of “top hat” section but with a pair of “flats” to allow it to pass through the hole from the fireside. See Fig 6.

If neither option is practical then a plain bush may be fitted. In all cases the weld should be of full penetration and from the fireside.

**Fig 6: Typical method for fitting a Fusible Plug bush to Steel Fireboxes**
